SERMA TECHNOLOGIES

**HAMAMATSU PHOTODIODES (DPD-S8576)
EVALUATION REPORT
(GLAST Project)
REPORT E01P1435 - JUNE 2002**

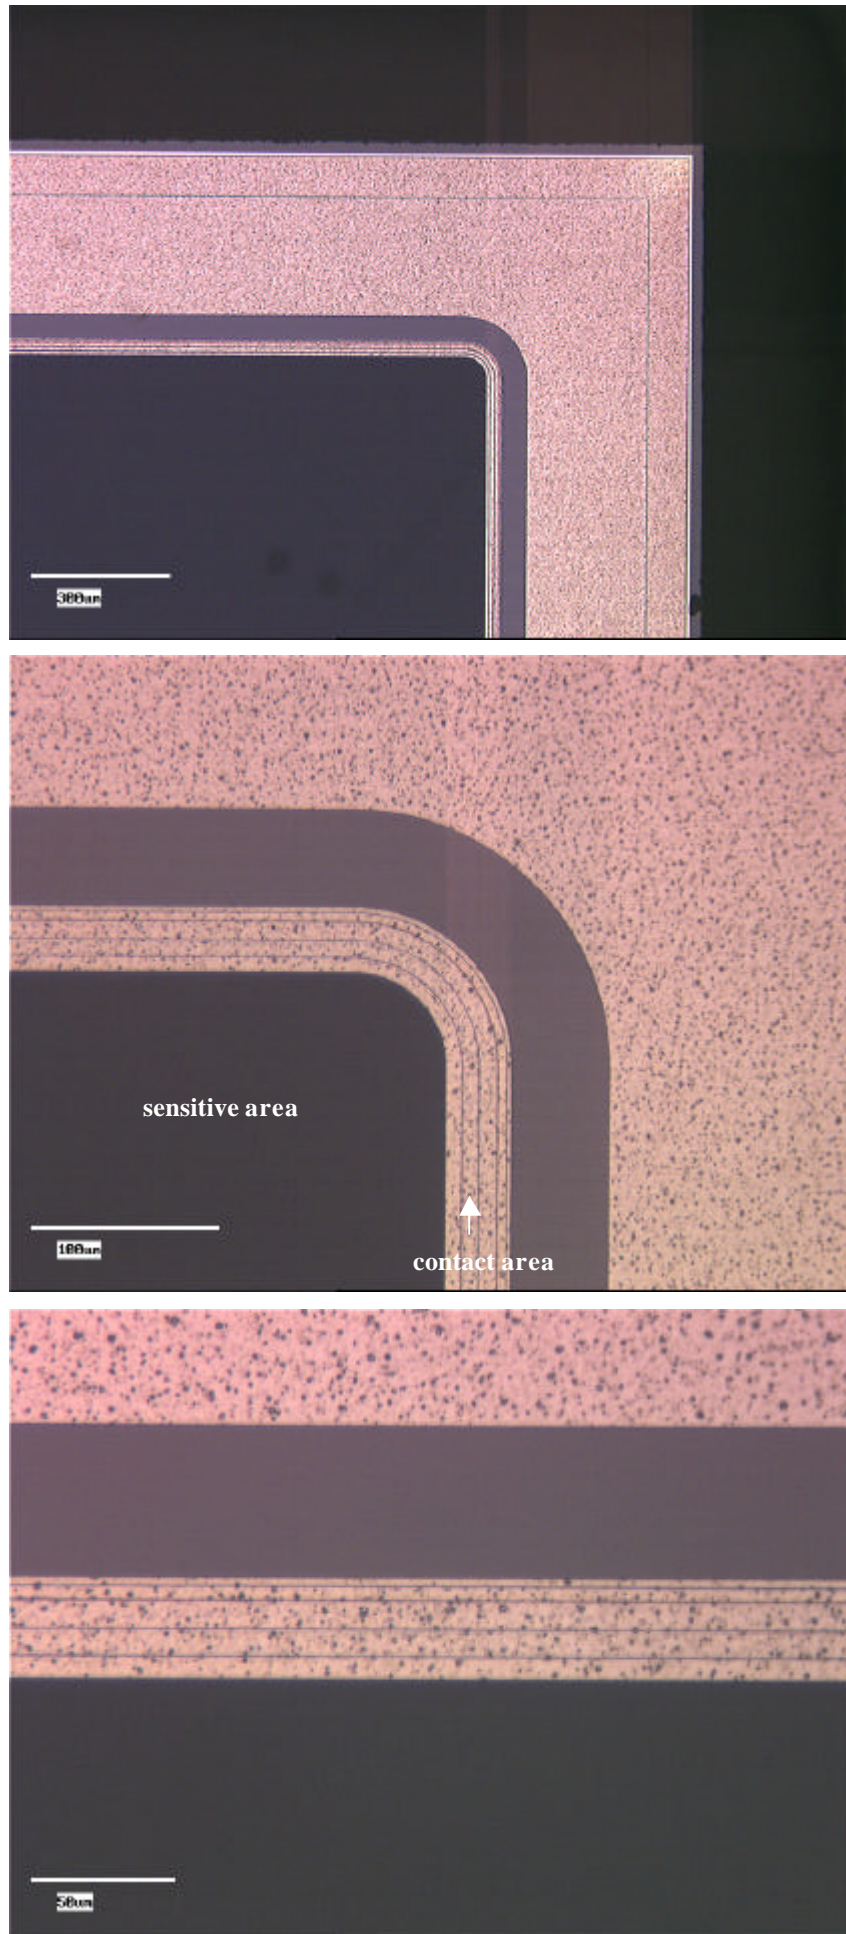
- Views of the dice are shown in Figure 15.
- The dice are silicon PIN diodes. A peripheric aluminum ring contacts the die. The sensitive area uses the most surface of the die. Figure 16.
- Details of the contact area (aluminum etched) are shown in Figure 16. Section views of the die B are shown in Figures 17 and 20.
- The die is contacted by aluminum lines on diffusions.
- The sensitive layer is covered by a thin silicon nitride over a P+ diffusion.

Figure 16. Optical details of the die metallization.
Top : mag 59.3X ; center : mag 239X ; bottom : mag 373X.

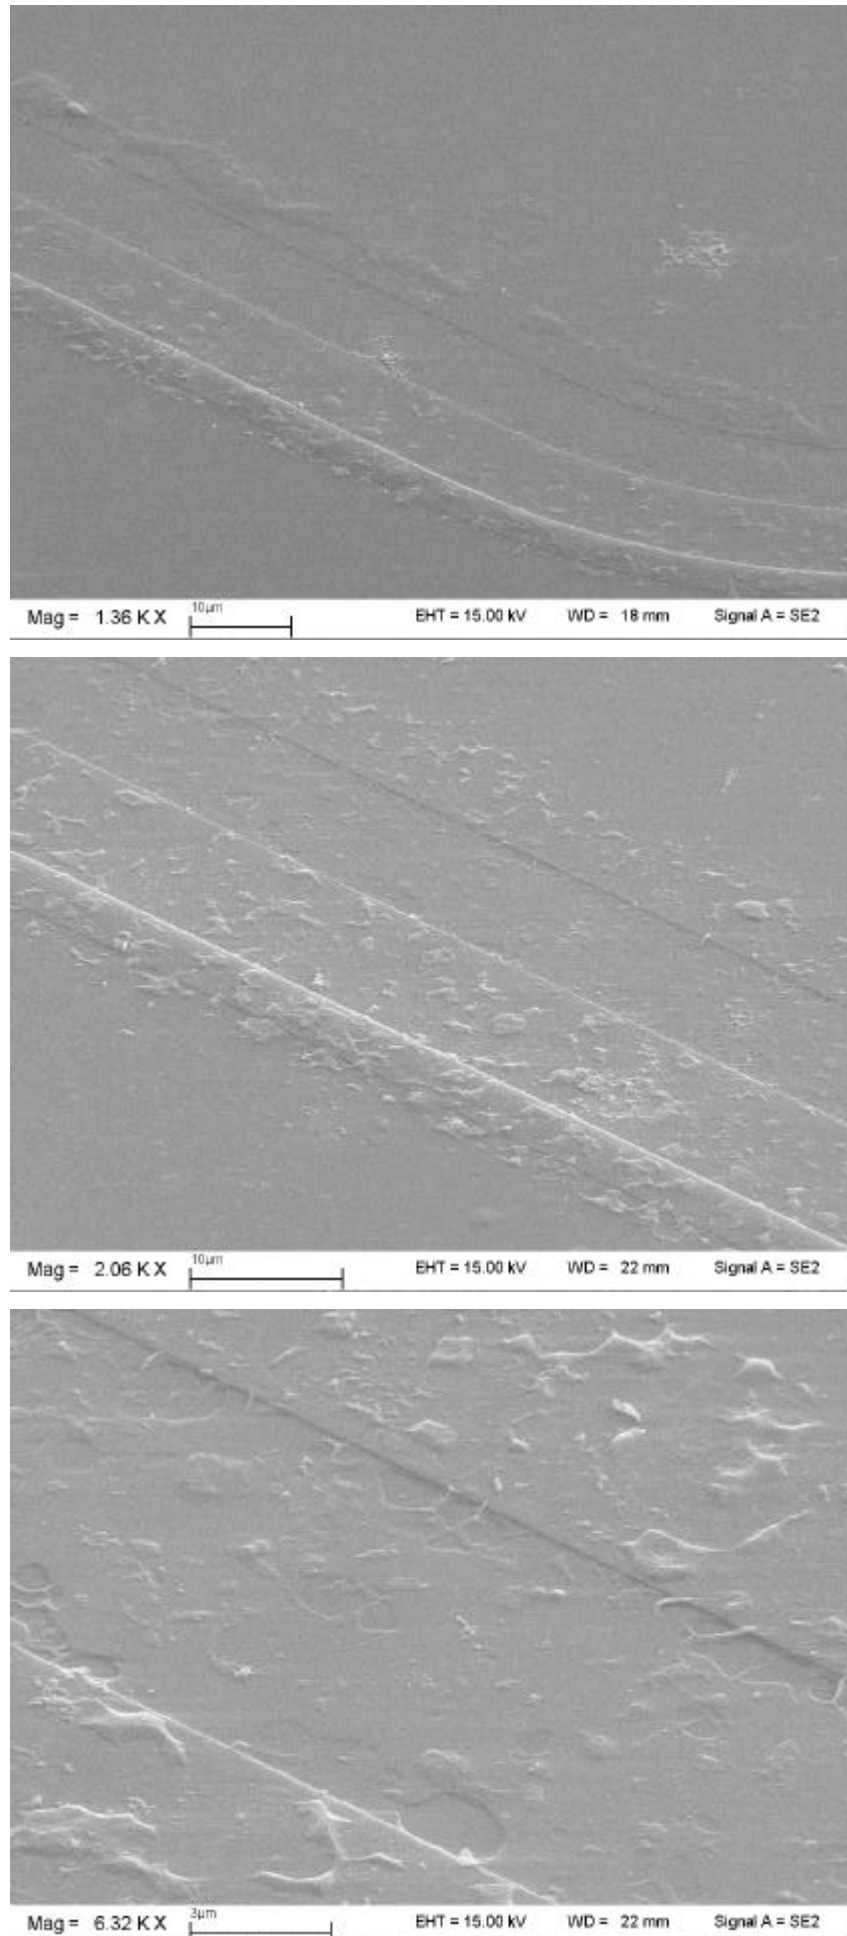
Figure 17. SEM details of aluminum to substrate contact area.
Top : mag 1360X ; center : mag 2060X ; bottom : mag 6320X.

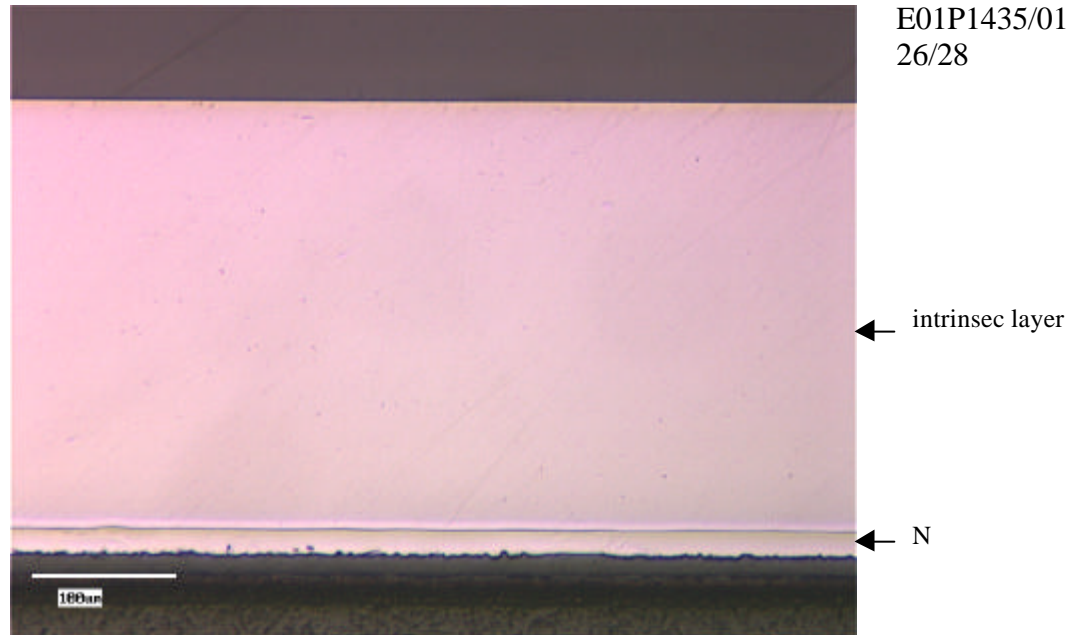
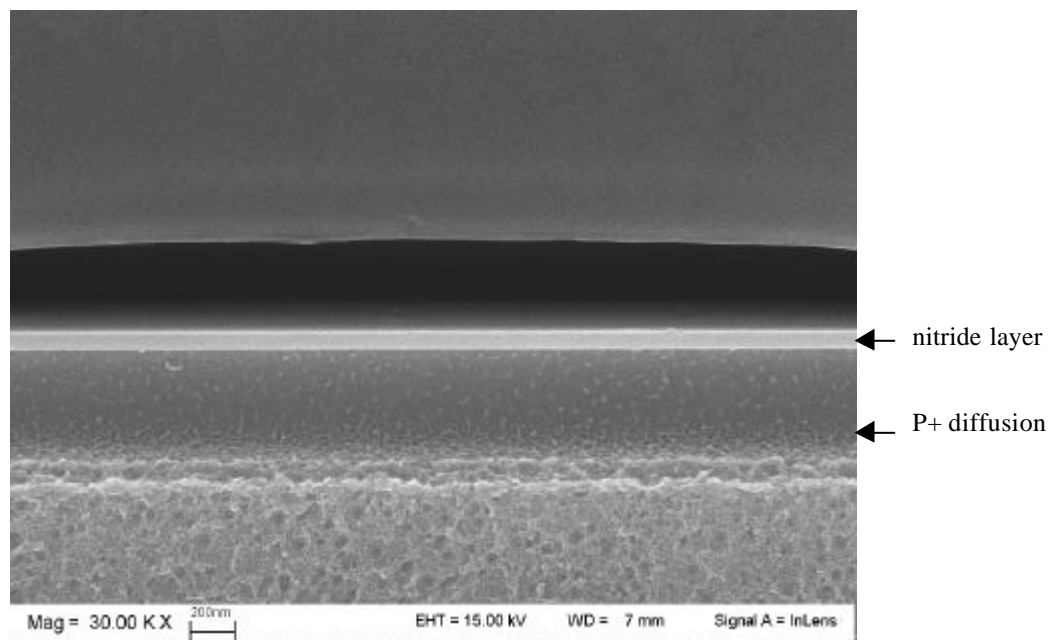
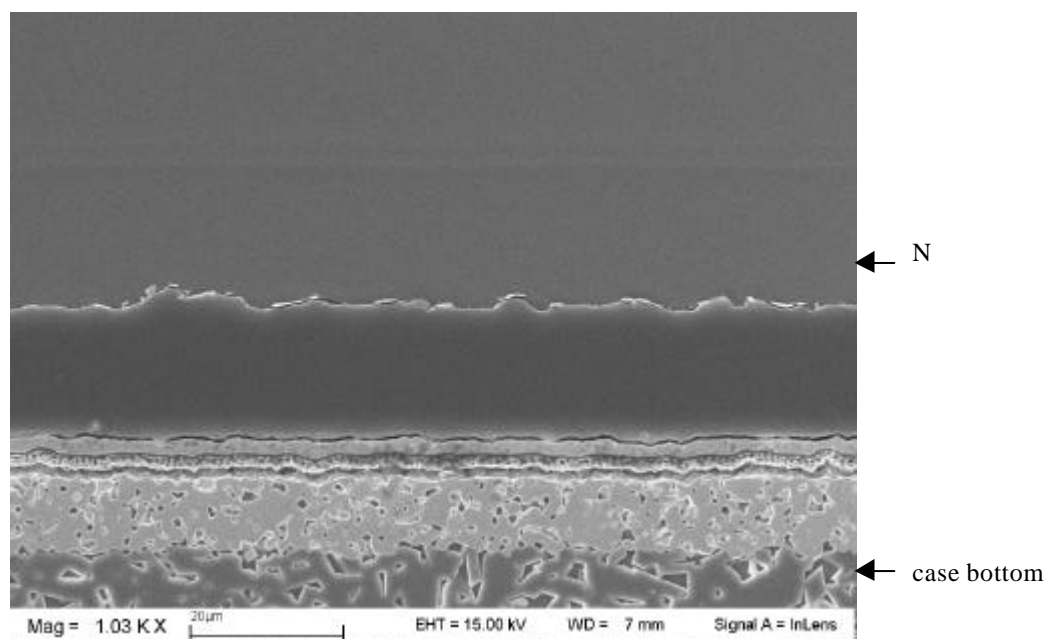
Figure 18. Optical and SEM views of diffusions.
Top : mag 186X ; center : mag 30000X ; bottom : mag 1030X.

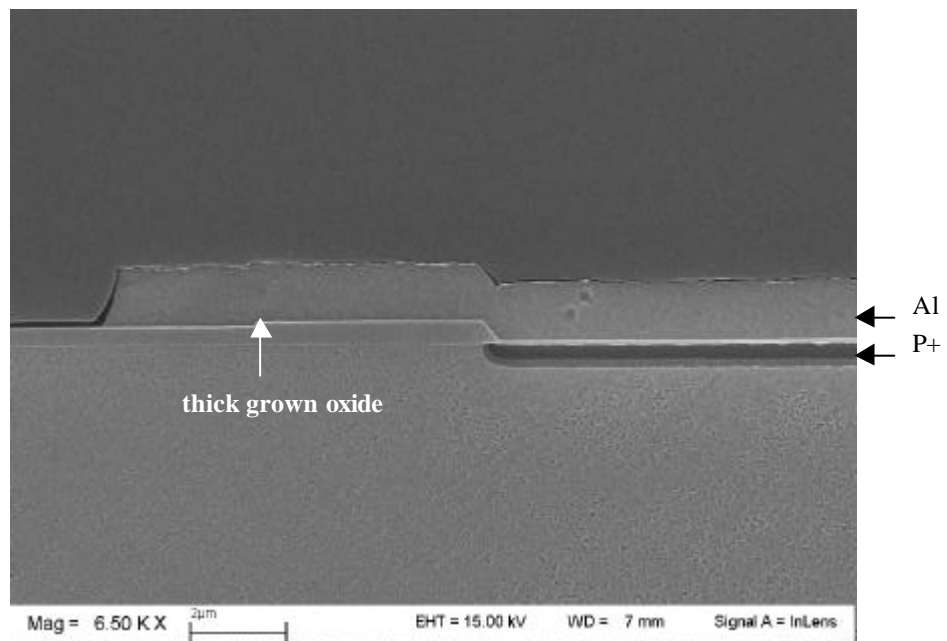
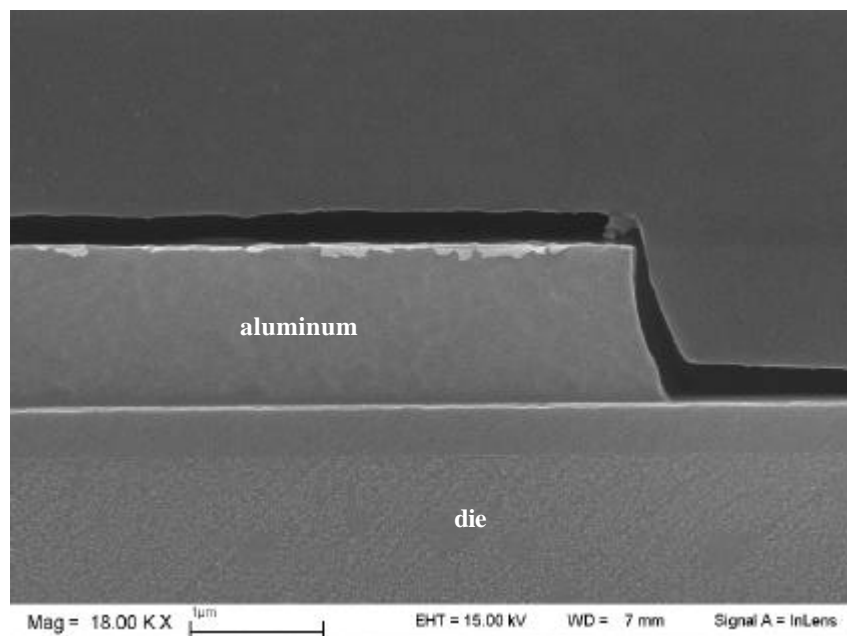
Figure 19. SEM views of metal layer.
Top : mag 6500X ; bottom : mag 18000X.

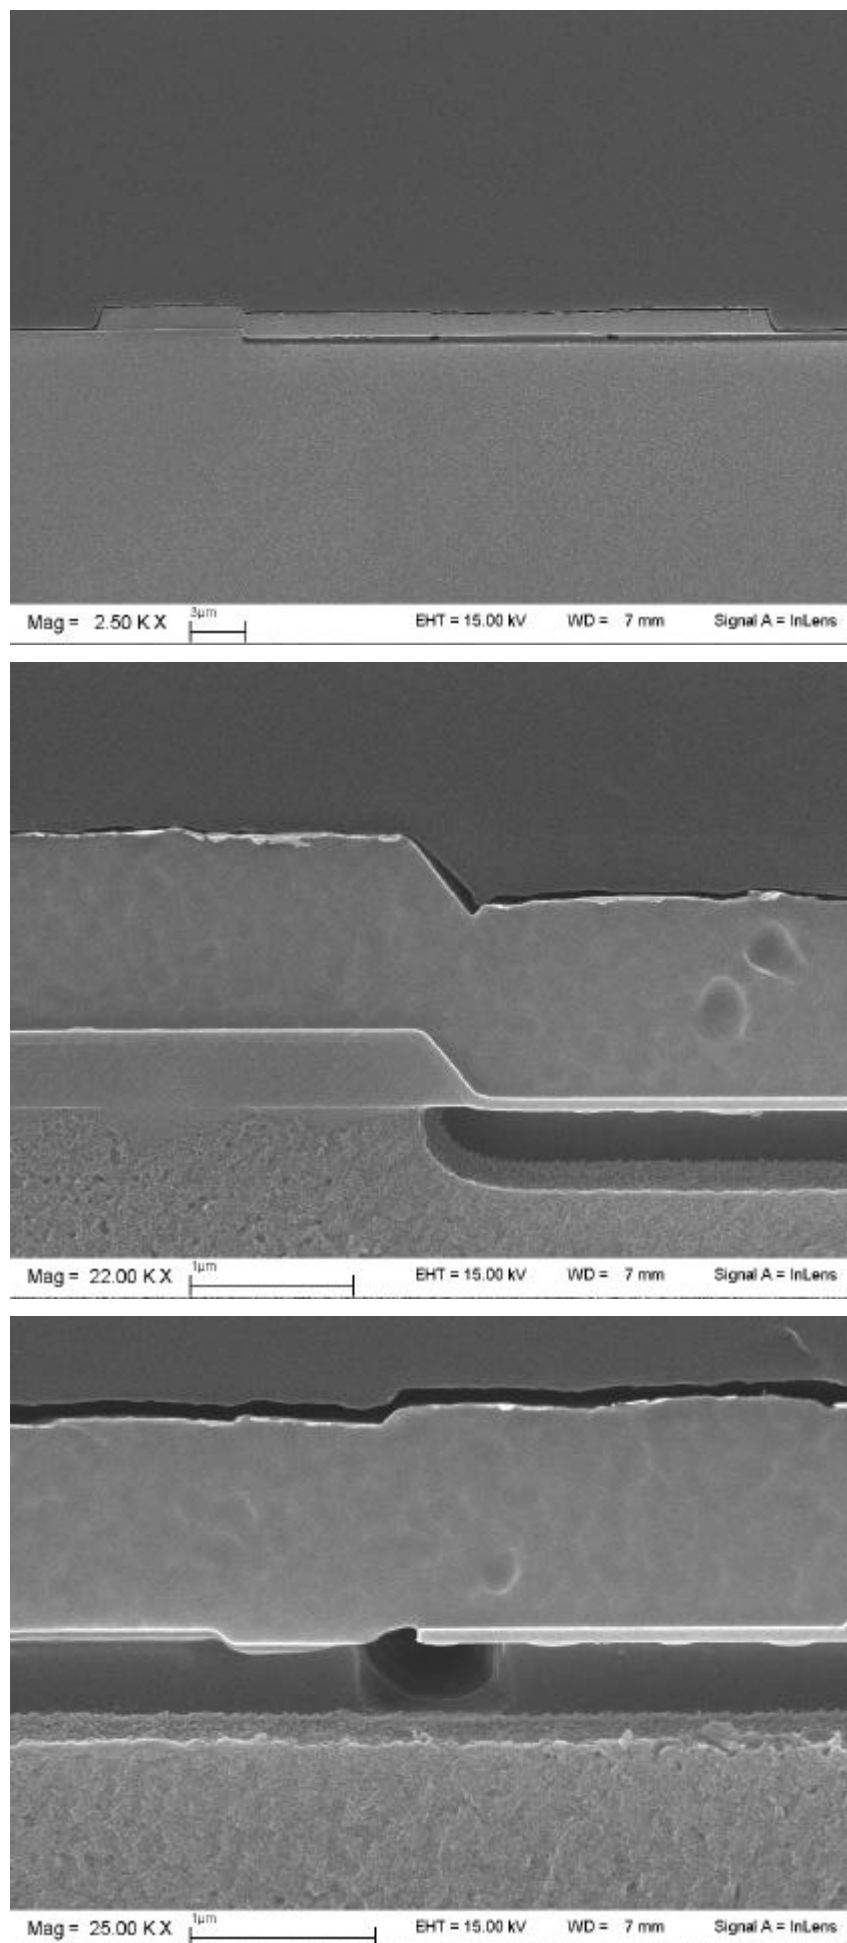
Figure 20. SEM views in section of metal to substrate contact area.
Top : mag 2500X ; center : mag 22000X ; bottom : mag 25000X.

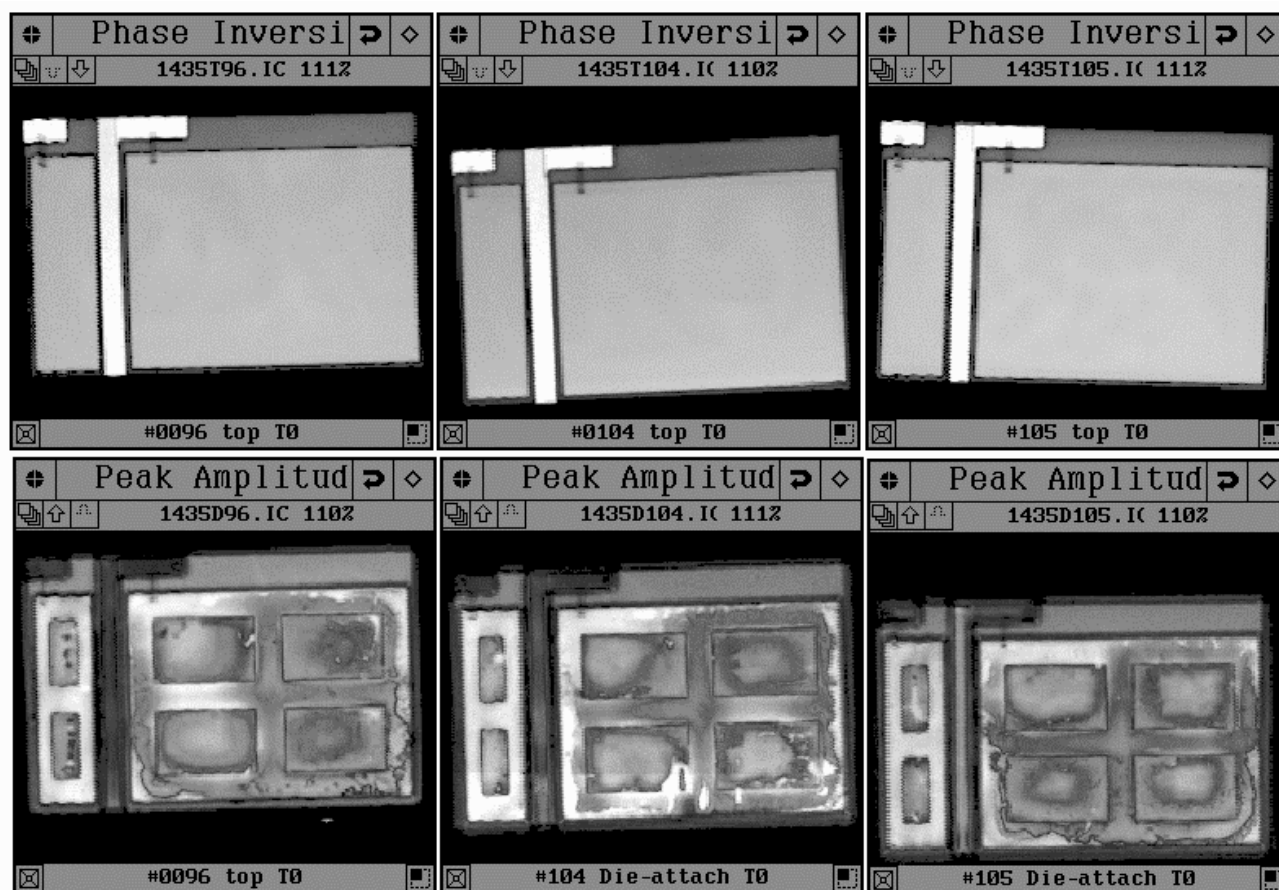
Figure 1. Acoustic microscopy, parts 96, 104 and 105 ; Initial.

Top : delamination image ; epoxy / die, epoxy / ceramic.

Bottom : amplitude image, die-attach interface.

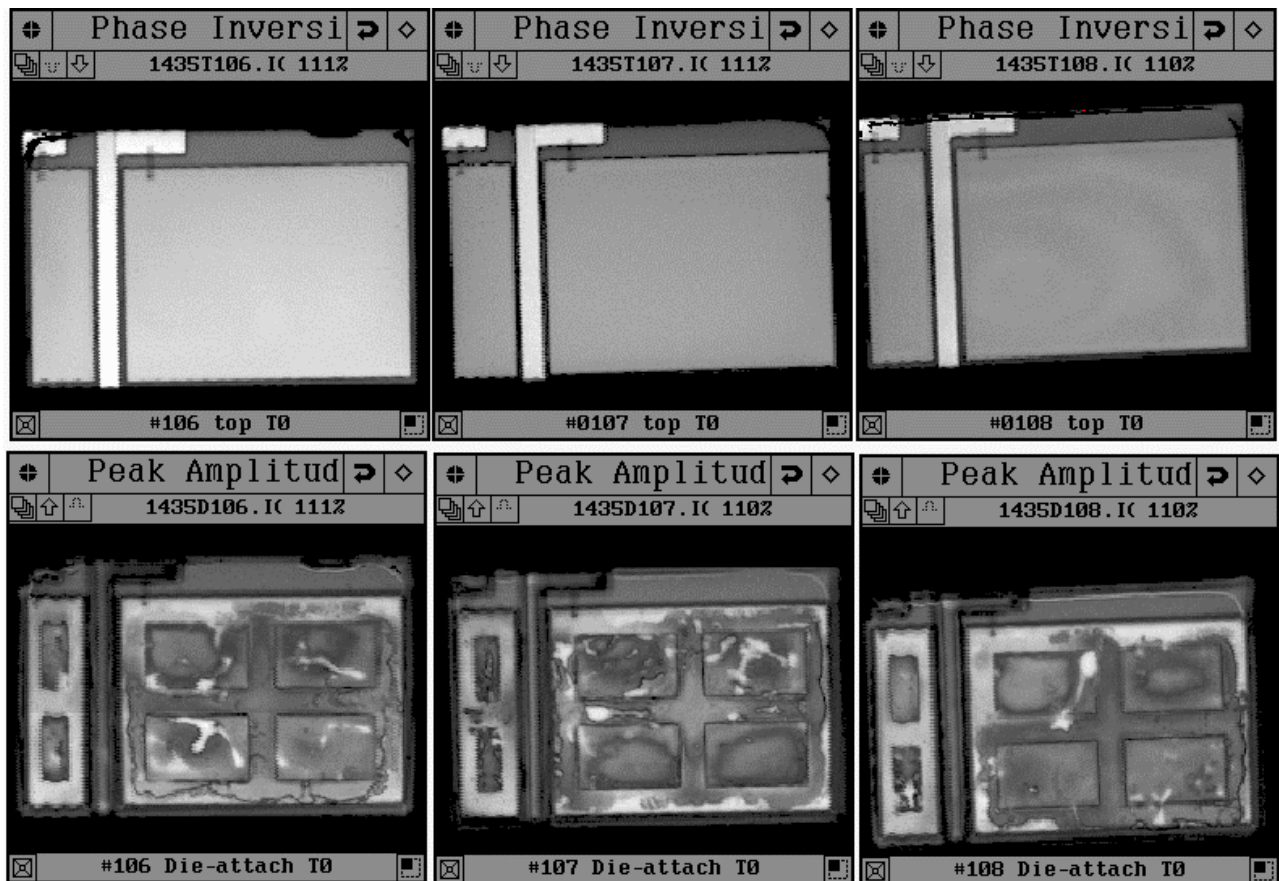
Figure 2. Acoustic microscopy, parts 106 to 108 ; Initial.
Top : delamination image ; epoxy / die, epoxy / ceramic.
Bottom : amplitude image, die-attach interface.

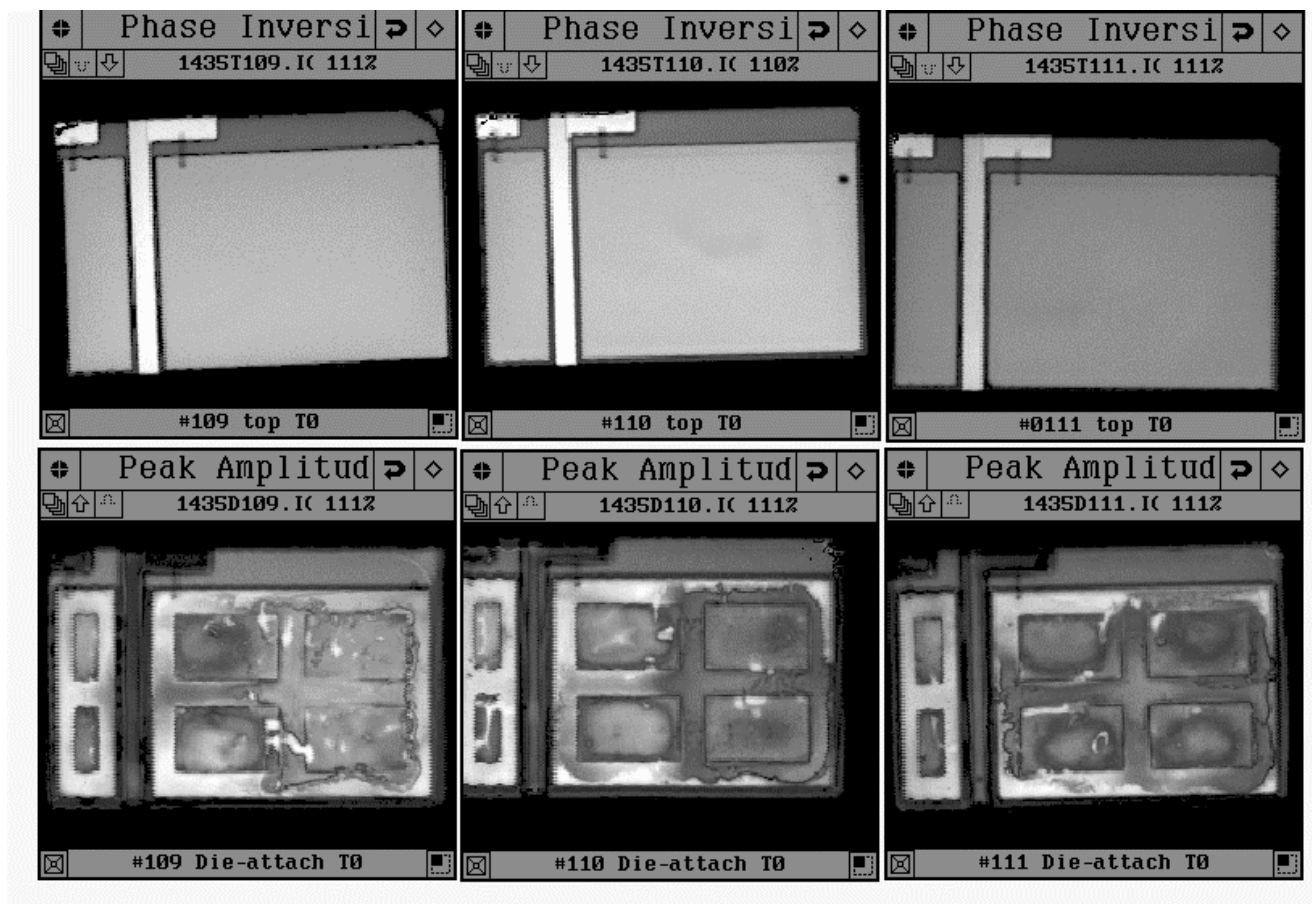
Figure 3. Acoustic microscopy, parts 109 to 111 ; Initial.
Top : delamination image ; epoxy / die, epoxy / ceramic.
Bottom : amplitude image, die-attach interface.

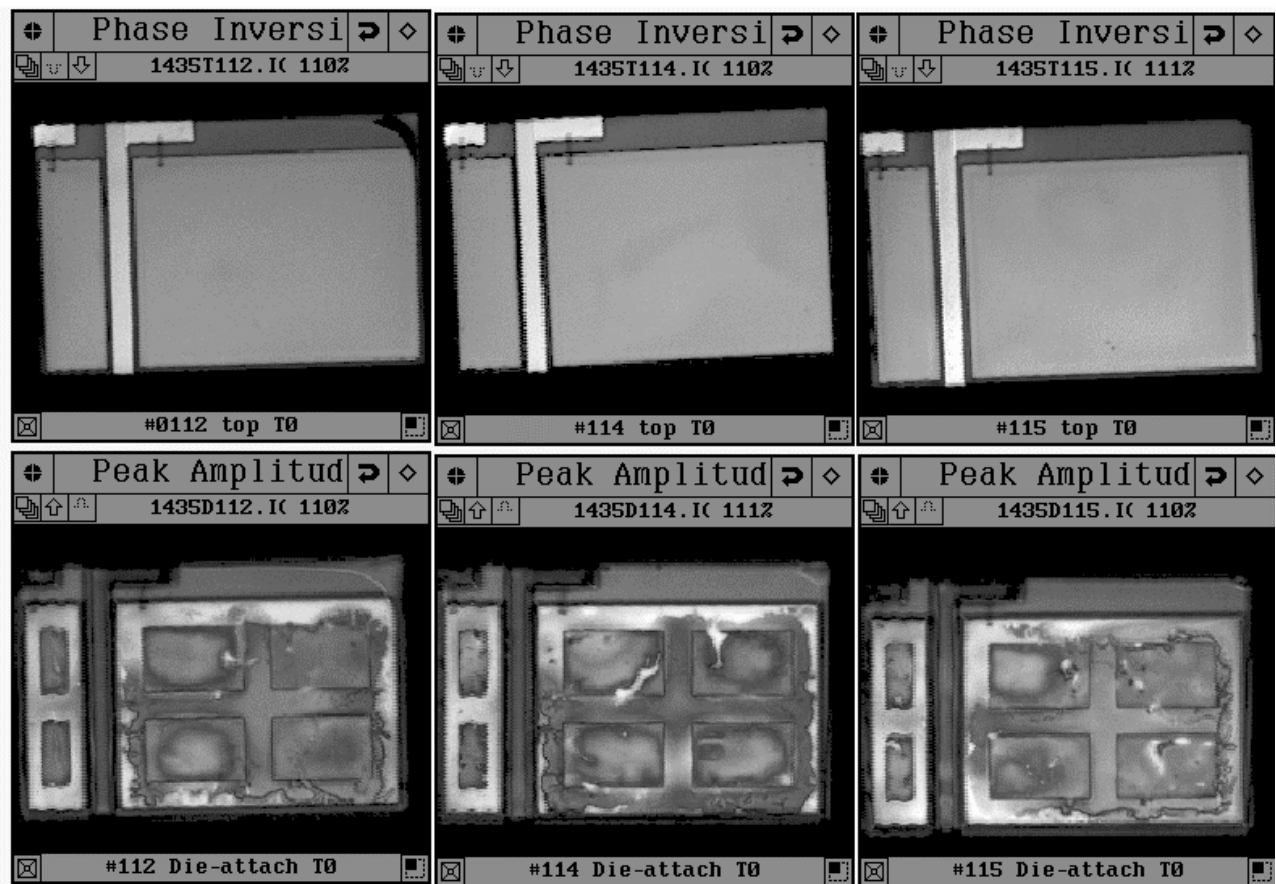
Figure 4. Acoustic microscopy, parts 112, 114 and 115 ; Initial.
Top : delamination image ; epoxy / die, epoxy / ceramic.
Bottom : amplitude image, die-attach interface.

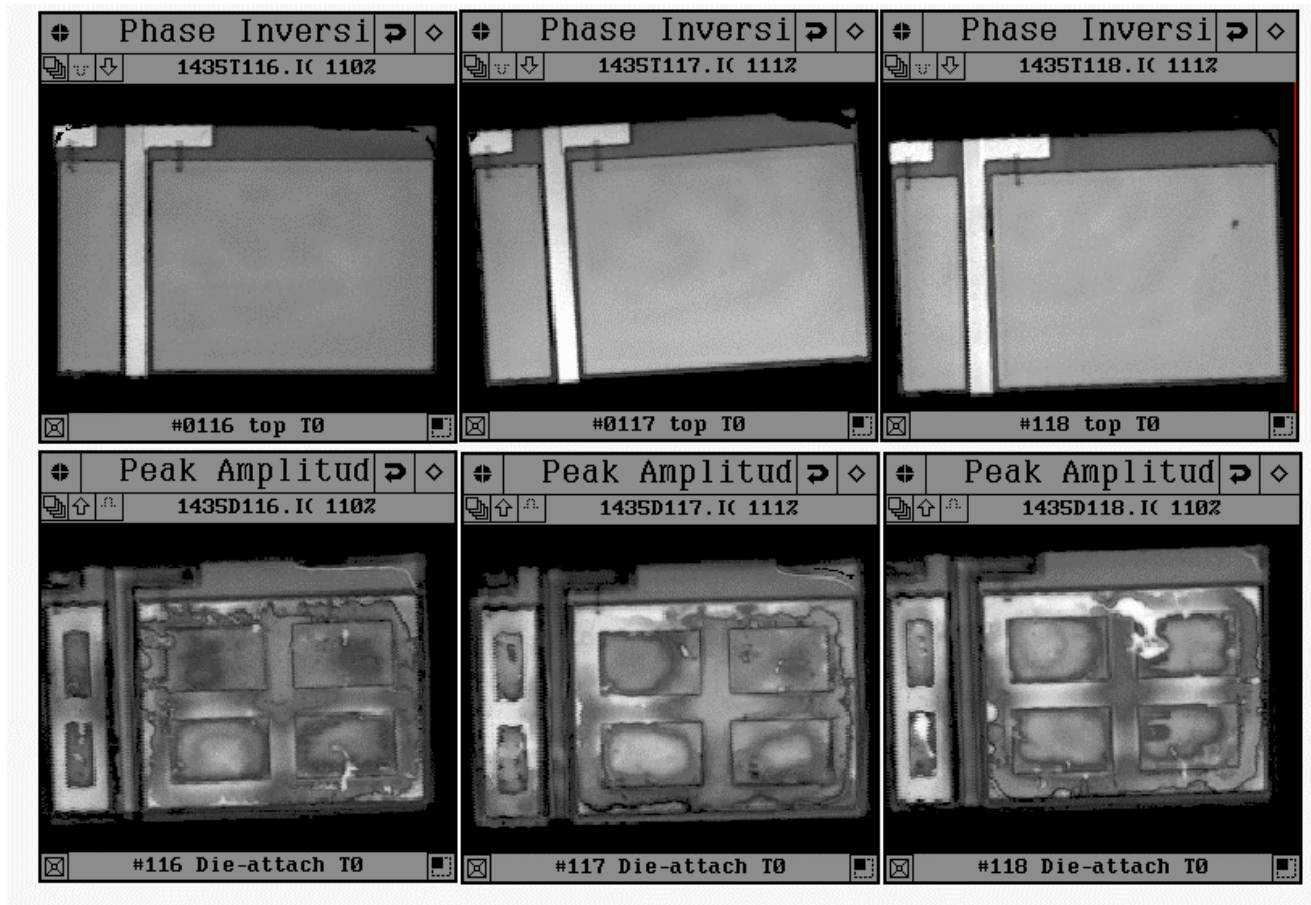
Figure 5. Acoustic microscopy, parts 116 to 118 ; Initial.
Top : delamination image ; epoxy / die, epoxy / ceramic.
Bottom : amplitude image, die-attach interface.

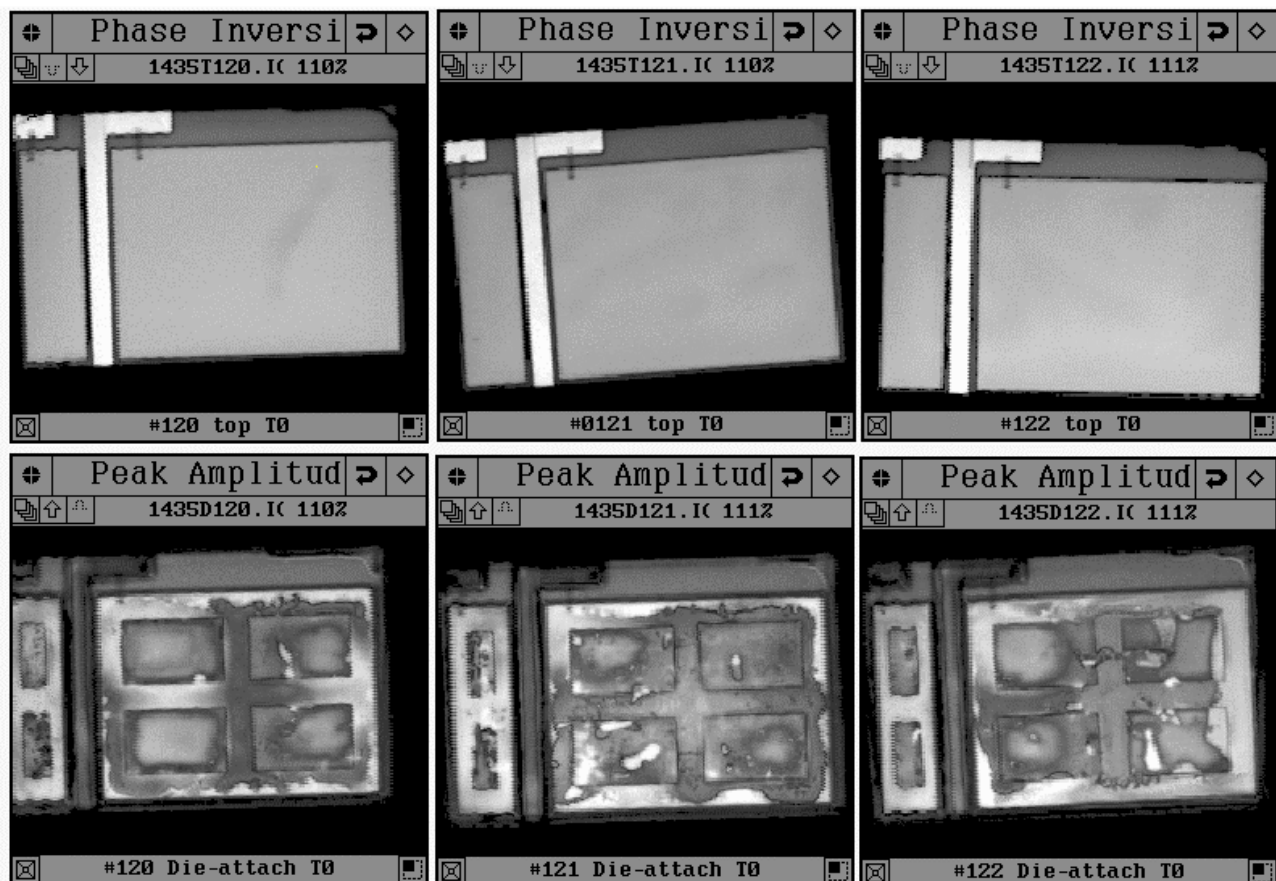
Figure 6. Acoustic microscopy, parts 120 to 122 ; Initial.
Top : delamination image ; epoxy / die, epoxy / ceramic.
Bottom : amplitude image, die-attach interface.

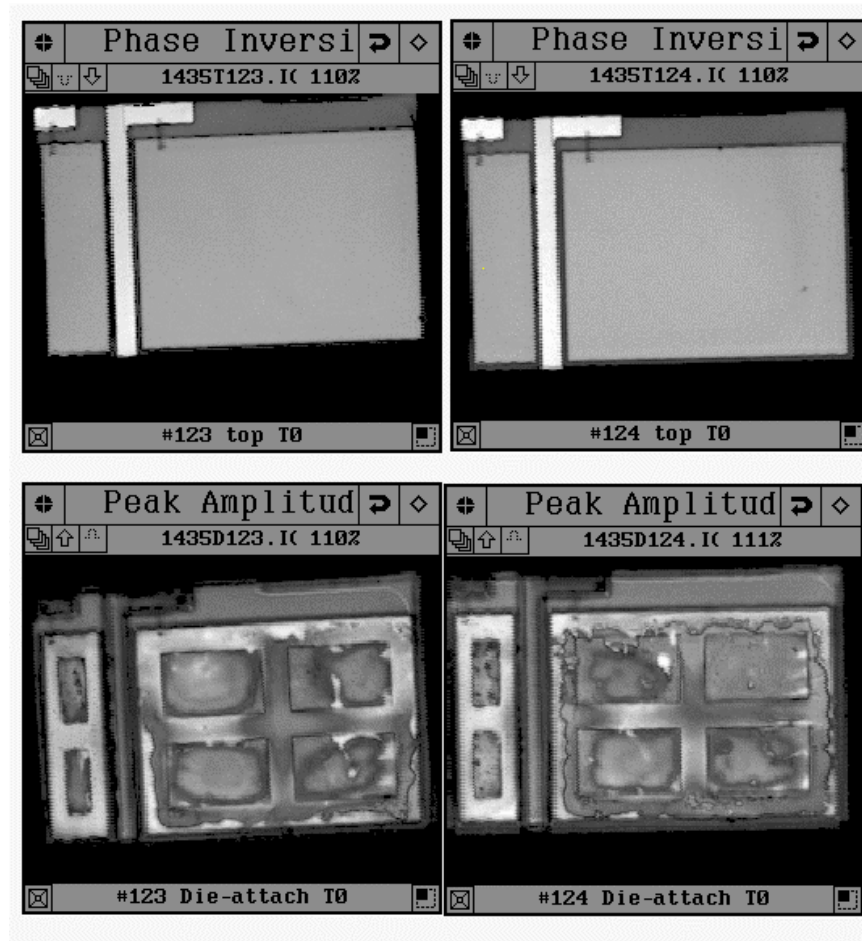
Top Scanning	DELAMINATION AT INTERFACE	
	epoxy/die	epoxy/ ceramic
Part reference (image ref.)		
N°105 (1435R105)	No	No
N°117 (1435R117)	No	No
N°123 (1435V123)	No	Beginning of delamination between die and separator

Figure 7. Acoustic microscopy, parts 123 and 124 ; Initial.
Top : delamination image ; epoxy / die, epoxy / ceramic.
Bottom : amplitude image, die-attach interface.

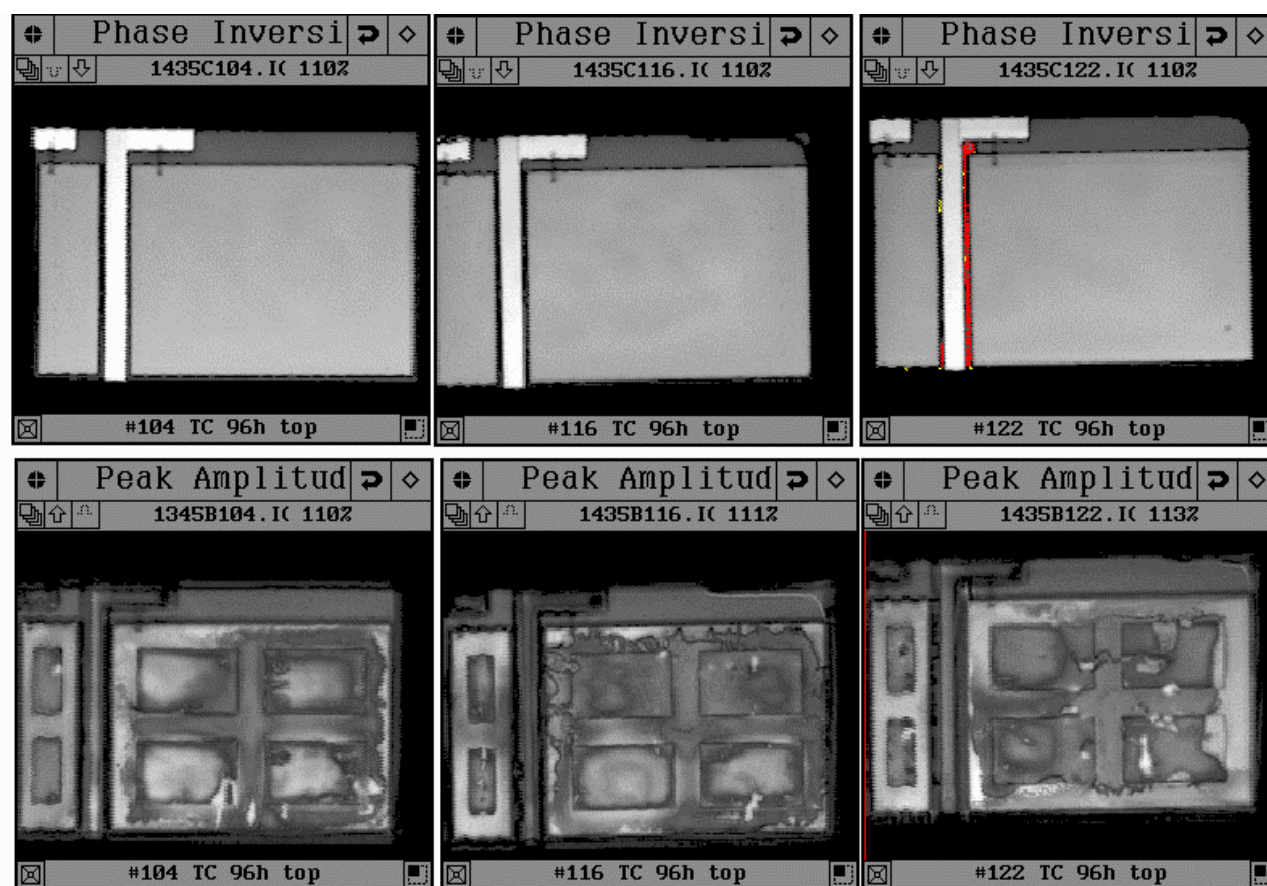
Figure 11. Acoustic microscopy, parts 104, 116 and 122.

Thermal cycling : 0°C / 50°C.

Top : delamination image ; epoxy / die, epoxy / ceramic.

Bottom : amplitude image, die-attach interface.

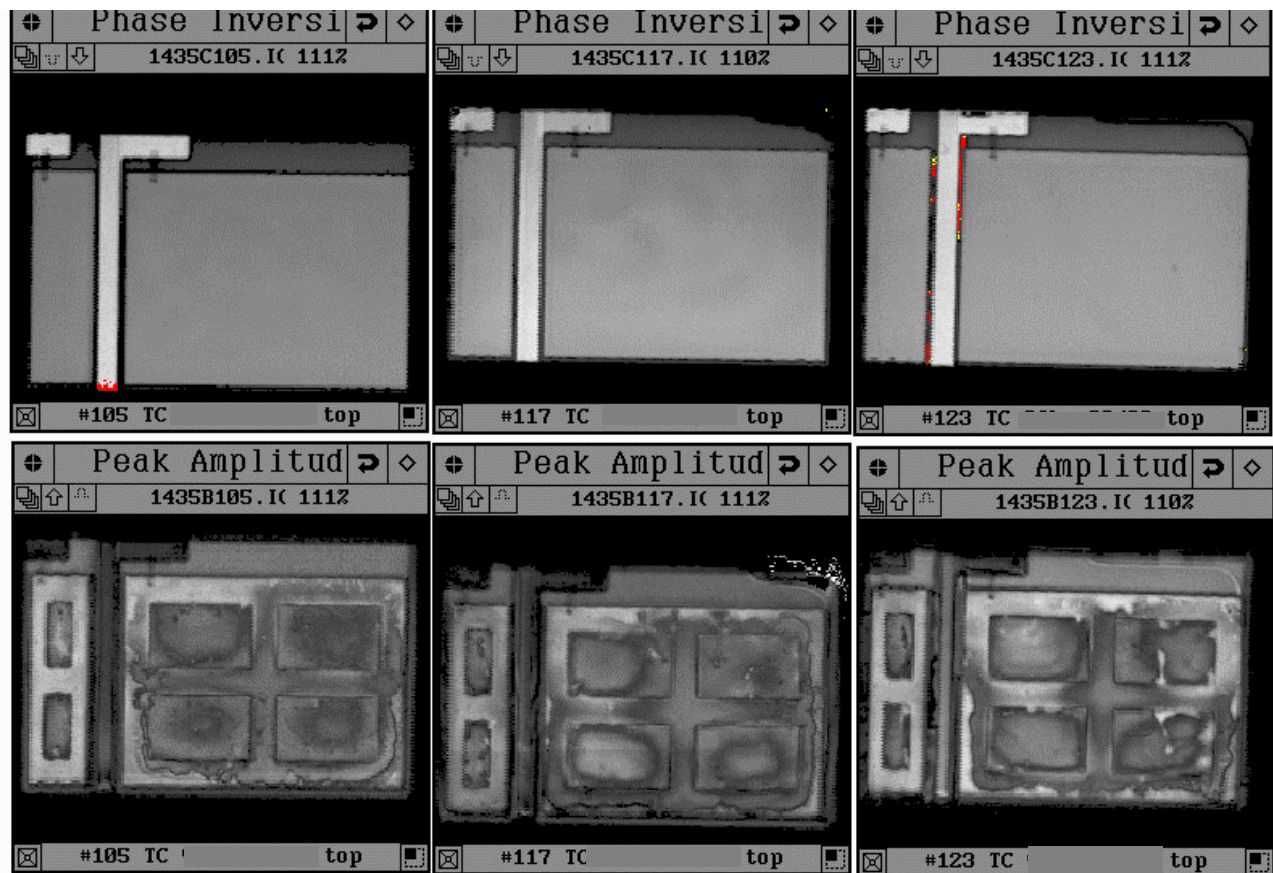
Figure 12. Acoustic microscopy, parts 105, 117 and 123.
Thermal cycling : -10°C / 60°C.
Top : delamination image ; epoxy / die, epoxy / ceramic.
Bottom : amplitude image, die-attach interface.

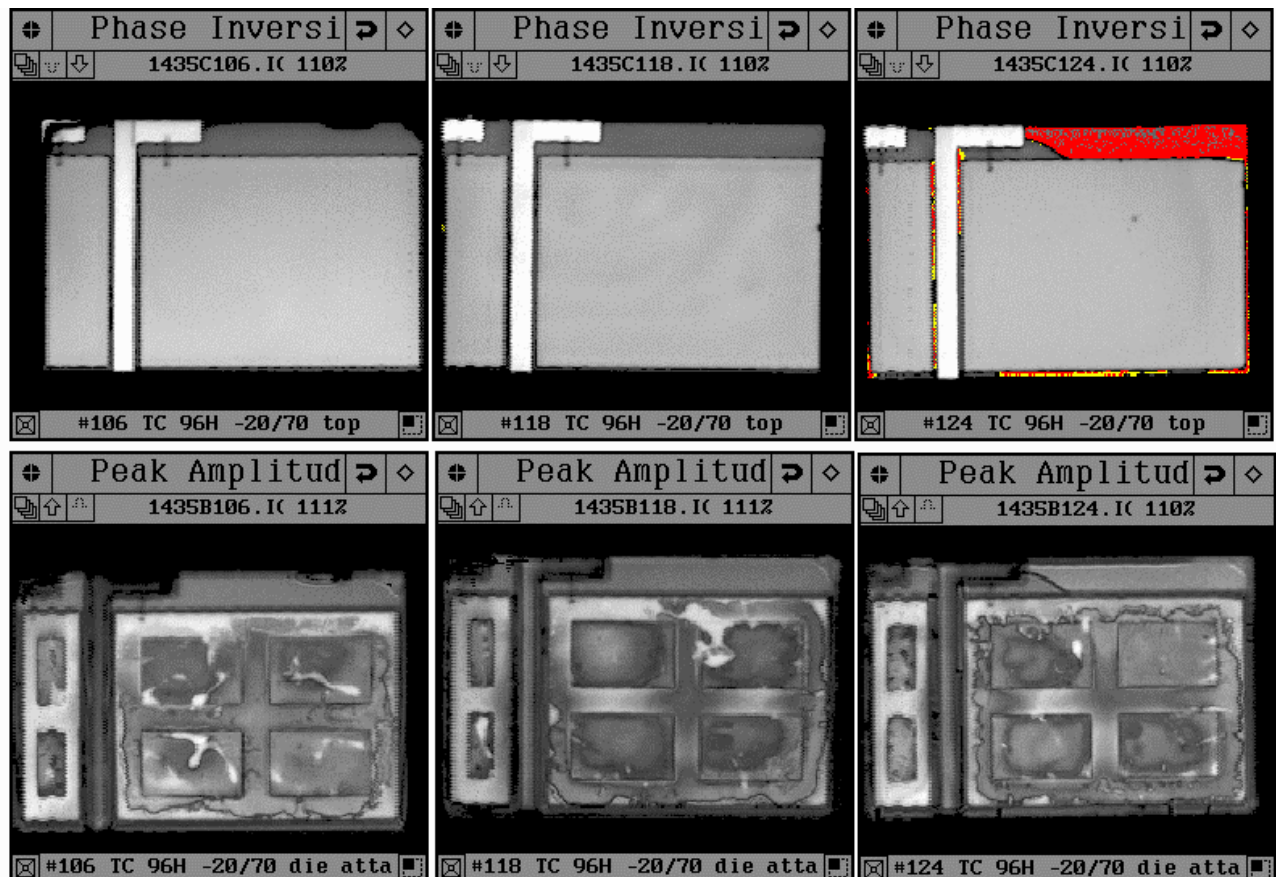
Figure 13. Acoustic microscopy, parts 106, 118 and 124.
Thermal cycling : -20°C / 70°C.
Top : delamination image ; epoxy / die, epoxy / ceramic.
Bottom : amplitude image, die-attach interface.

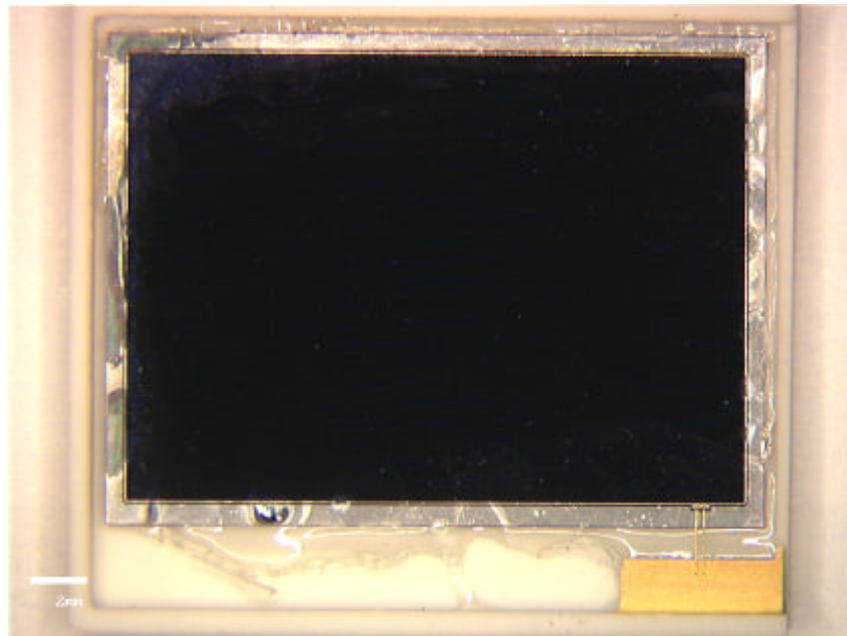
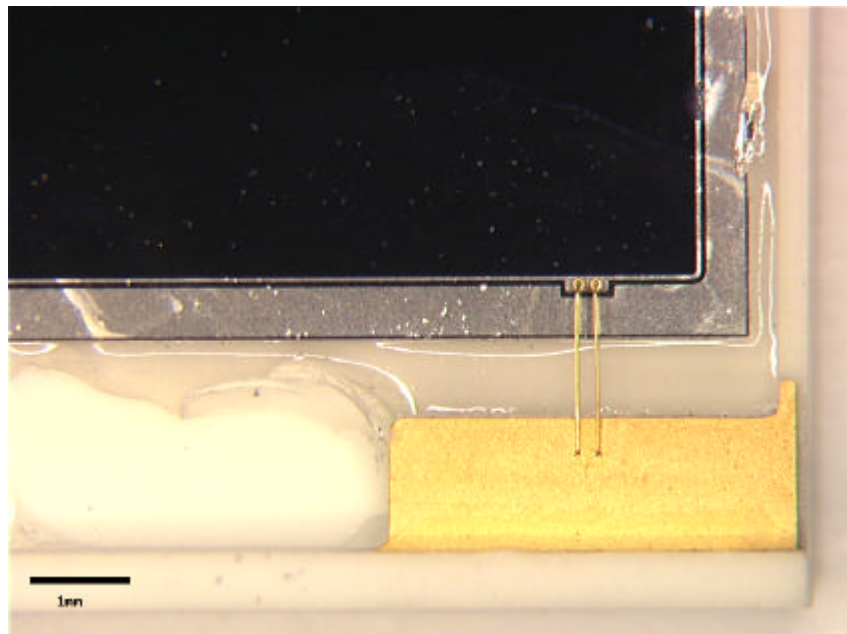
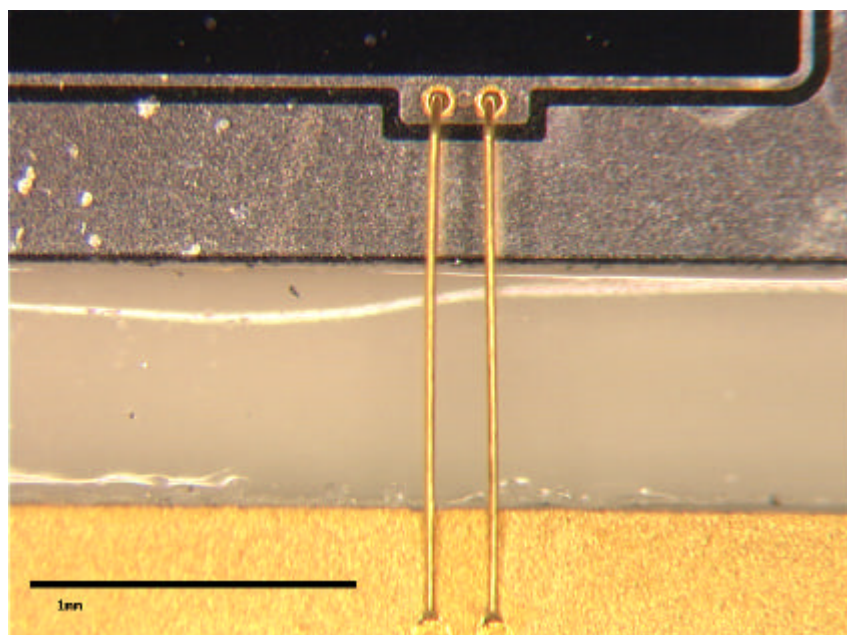
- A SEM inspection by secondary electrons (ES) and by electrons beam induced current (EBIC) did not reveal any defect (Part 0096 and 0187, Pin B).
No defect as black areas characteristic of defect in the bulk was identified in this part.
This EBIC technique appeared satisfactory in order to inspect defect in the die.

Figure 1. General and detailed external optical views of the die, Pin B, # 0096.
Top : mag 5X ; center : mag 15X ; bottom : mag 44X.

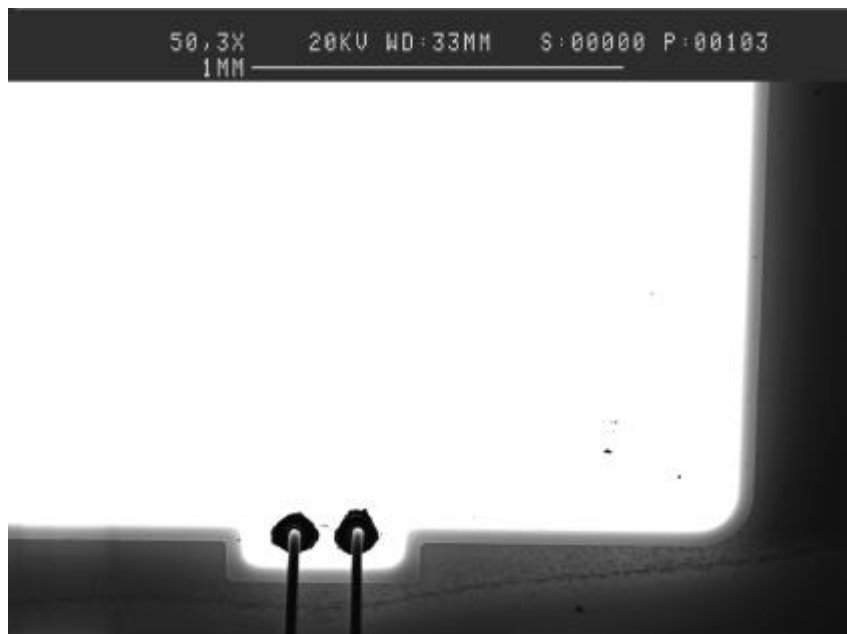
- The Part 0128 Pin B with correct dark current was used for comparison with the other parts : no difference was observed.

Figure 5. Optical and SEM detailed views of the die surface, Pin B, # 0128.
 Top : optical view, mag 45X ; center : Secondary Electrons SEM view, mag 5X ;
 Bottom : EBIC SEM view, mag 50X.
